# Manhole Inspection Summary

Manhole # S02WW1011MH

**Location** Address: **6305 Fordham Dr**

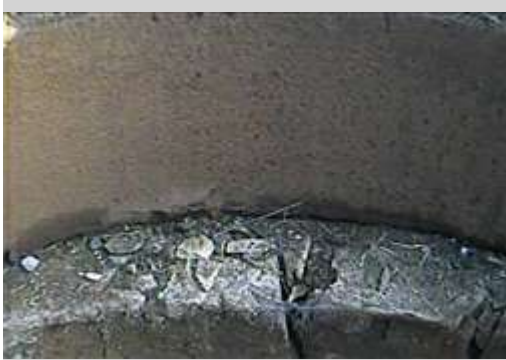
Offset: **2** (in.)

offset

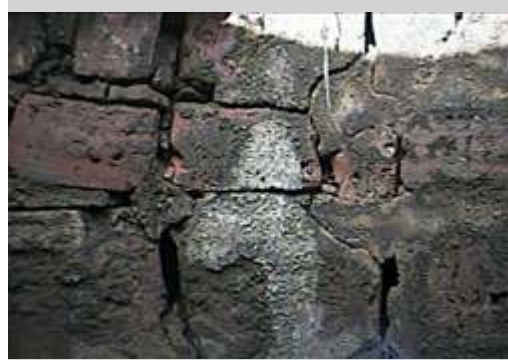
Defect

Condition: ☐ Sound ☐ Cracked ☐ Root Intrusion ☒ **Loose Brick** ☒ **Deteriorated**

Infiltration: ☐ None ☒ **Joint** ☐ Cracks ☒ **Mortar** ☐ Roots ☐ Wall

cracks in adjustment

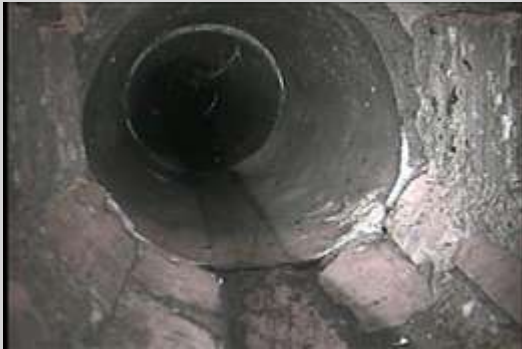
### 8 in. Circular Gravity Sewer Pipe Out @ 12 O'Clock

Infiltration: **None** Pipe Seal Cond: **Sound**

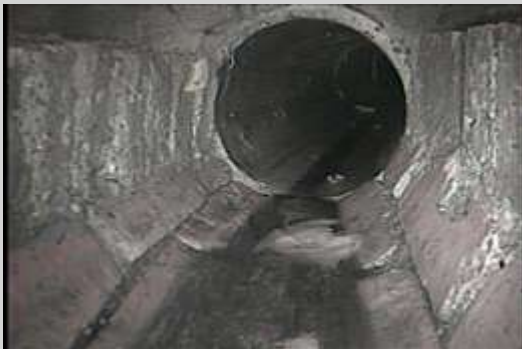
### 8 in. Circular Gravity Sewer Pipe In @ 7 O'Clock

Infiltration: **None** Pipe Seal Cond: **Sound**
